**Flood Control Project Maintenance  
Levee Inspections**  
**LMA District Cover Sheet**  
**Spring 2009 Levee Inspection Results**

**Reclamation District No. 0544**

**Levee Inspection Report By Mile - Spring 2009**

Waterway	Bank	Unit Miles	Inspection Start/End	Inspector
Unit No. 01 San Joaquin River	Left	6.10	04/01/2009 04/01/2009	Richard Willoughby

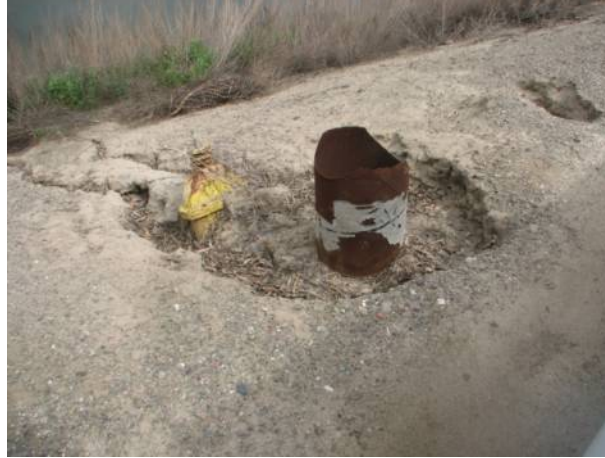
Levee Mile Report Line	10
Start Levee Mile	0.57
End Levee Mile	0.57
Location	Water Side
Category	Earthen Levee
Item	Slope Stability
Erosion around siphon pipe at LM 0.57

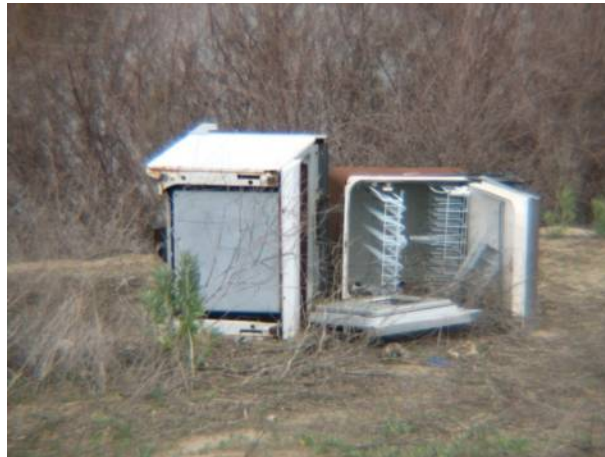
Levee Mile Report Line	23
Start Levee Mile	3.56
End Levee Mile	3.56
Location	Water Side
Category	Earthen Levee
Item	Encroachments
Garbage at waterward berm at LM 3.56

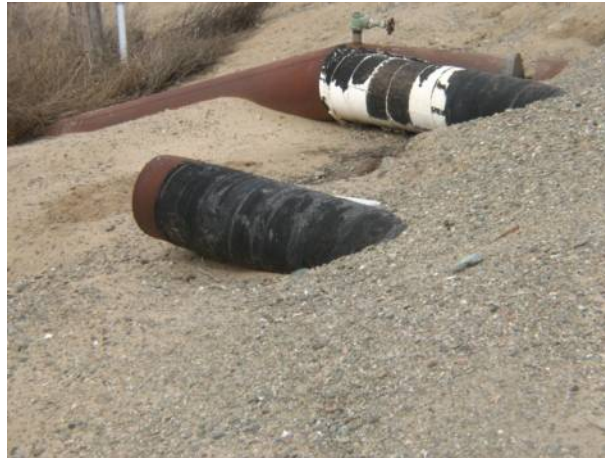
Levee Mile Report Line	24
Start Levee Mile	2.65
End Levee Mile	2.65
Location	Crown
Category	Earthen Levee
Item	Encroachments

Abandoned pipe at LM 2.65 landside view

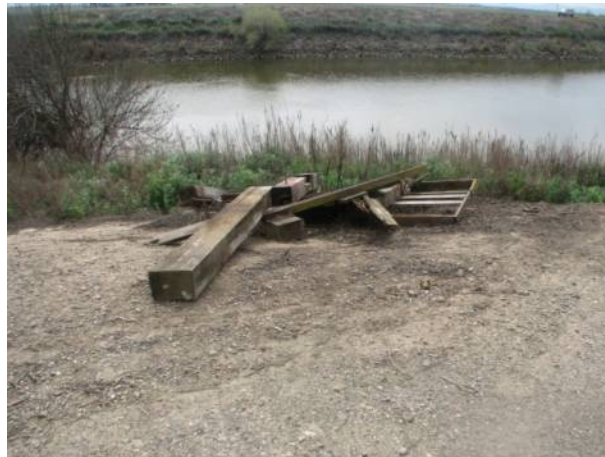
Levee Mile Report Line	27
Start Levee Mile	3.29
End Levee Mile	3.29
Location	Water Side
Category	Earthen Levee
Item	Encroachments

Garbage on waterwade shoulder at LM 3.29
